**COTTESMORE  
RUTLAND**

**TREE-RING ANALYSIS OF TIMBERS  
FROM A NUMBER OF HOUSES**

**Alison Arnold and Robert Howard**

**JANUARY 15 2017**

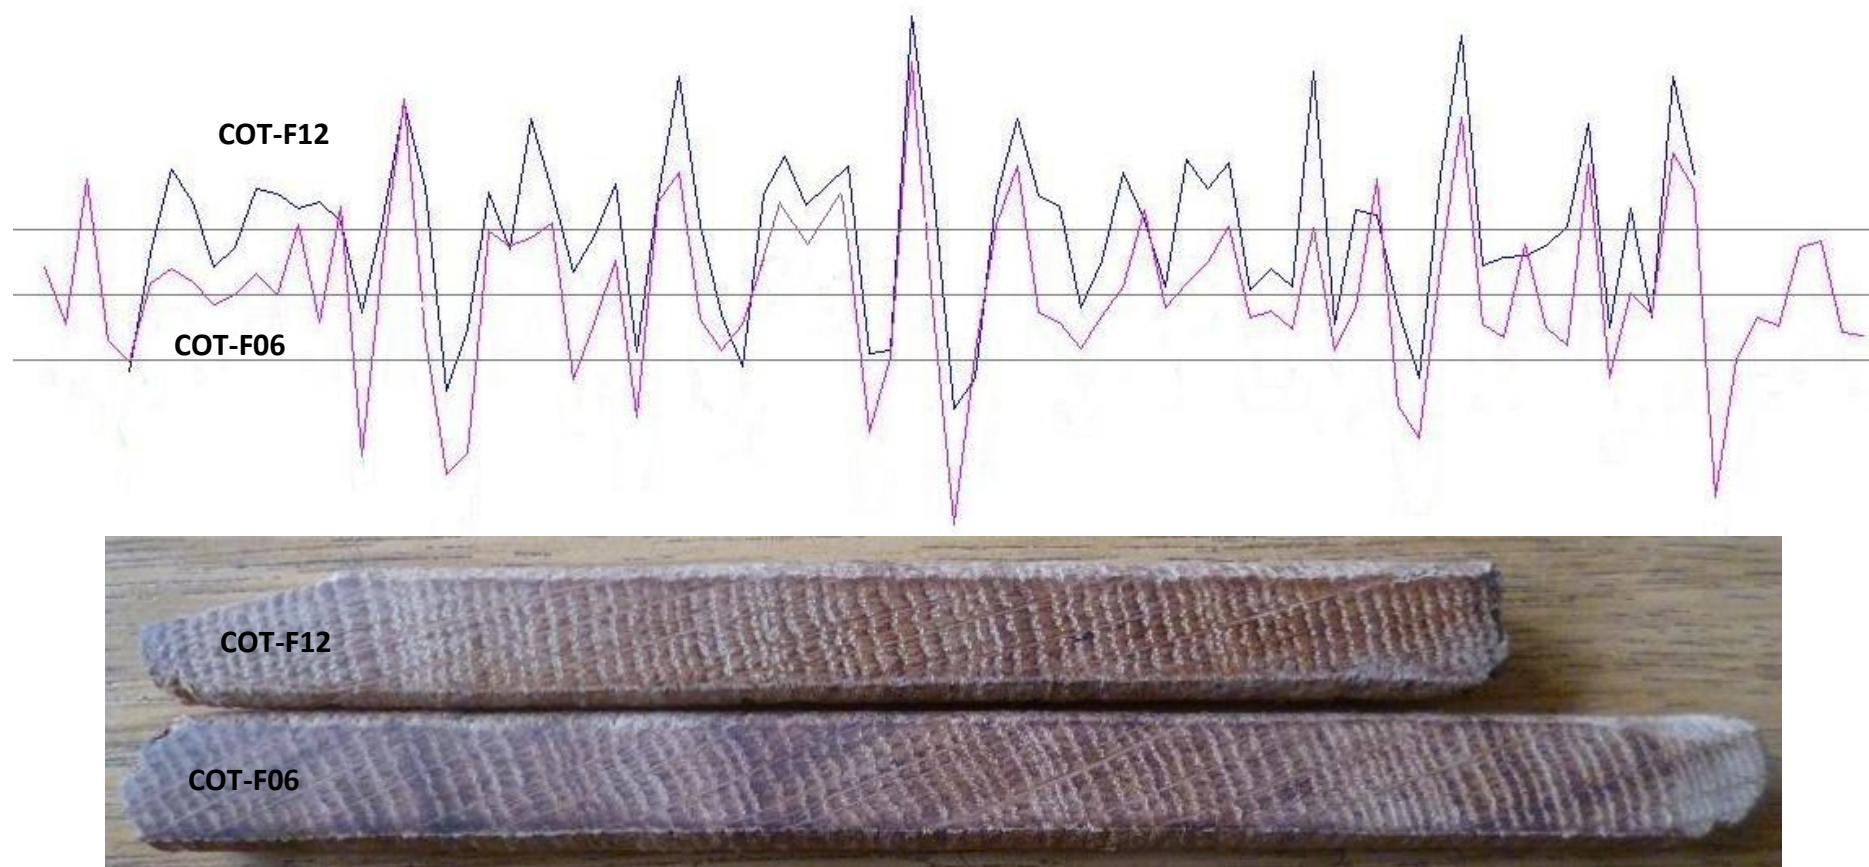
**Figure 3:** Graphic representation of the cross-matching of two samples, COT-F06 and F12

When cross-matched at the correct positions, as here, the variations in the rings of these two samples (where they overlap) correspond with a high degree of similarity. As the ring widths of one sample increase (represented by peaks in the graph), or decrease (represented by troughs), so too do the annual ring widths of the second sample. This similarity in growth pattern is a result of the two trees represented having grown in the *same place* at the *same place*. The growth ring pattern of two samples from trees grown at different times would never correspond so well.

Tree-ring dating relies on a few simple, but quite fundamental, principles. Firstly, as is commonly known, trees (particularly oak trees, the timber most commonly used in building construction until the introduction of pine from the late eighteenth century onwards) grow by adding one, and only one, growth-ring to their circumference each, and every, year. Each new annual growth-ring is added to the outside of the previous year's growth just below the bark. The width of this annual growth-ring is largely, though not exclusively, determined by the weather conditions during the growth period (roughly March–September). In general, good conditions produce wider rings and poor conditions produce narrower rings. Thus, over the lifetime of a tree, the annual growth-rings display a climatically influenced pattern. Furthermore, and importantly, all trees growing in the same area at the same time will be influenced by the same growing conditions and the annual growth-rings of all of them will respond in a similar, though not identical, way (**Fig 3**).

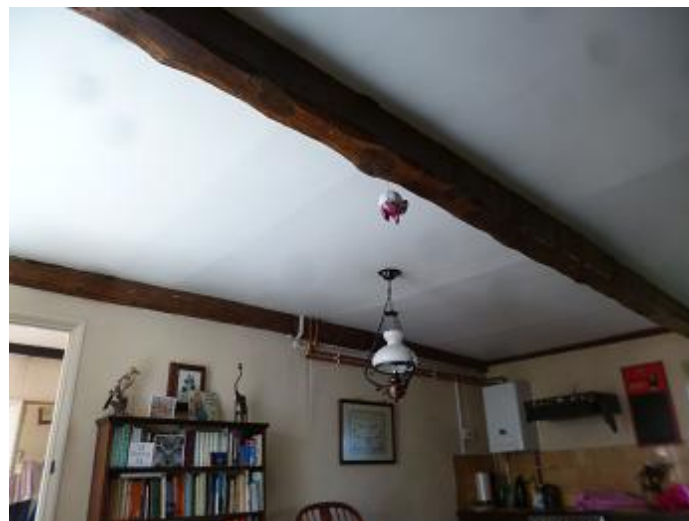
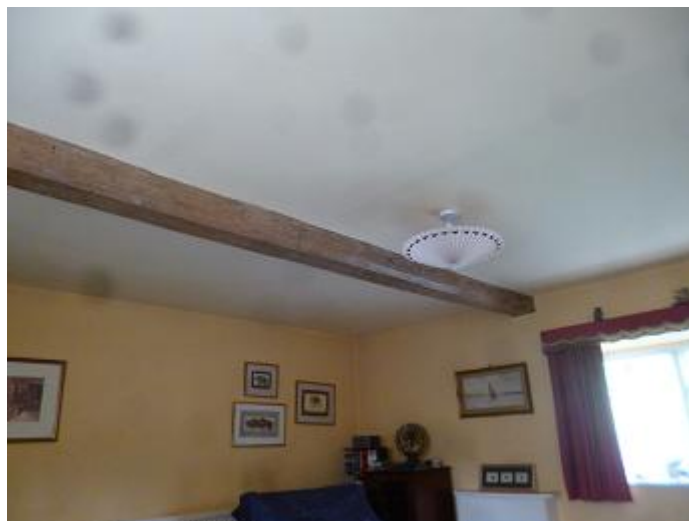
**Figure 5:** View of the timbers at Honeypot Cottage

The latest timbers detected in this programme of tree-ring dating are represented by samples CTM-A01–A03 from the ceiling beams at Honeypot Cottage (these samples also dated as part of site sequence CTMSSQ03). One of these samples, CTM-A03, again retains complete sapwood, the last ring produced by the source tree before it was felled. In this case this last ring, and thus the felling of the tree, is dated 1782. Given that the near identical position of the heartwood/sapwood boundary on the other two samples from Honeypot Cottage, it is likely that they too were felled in 1782.

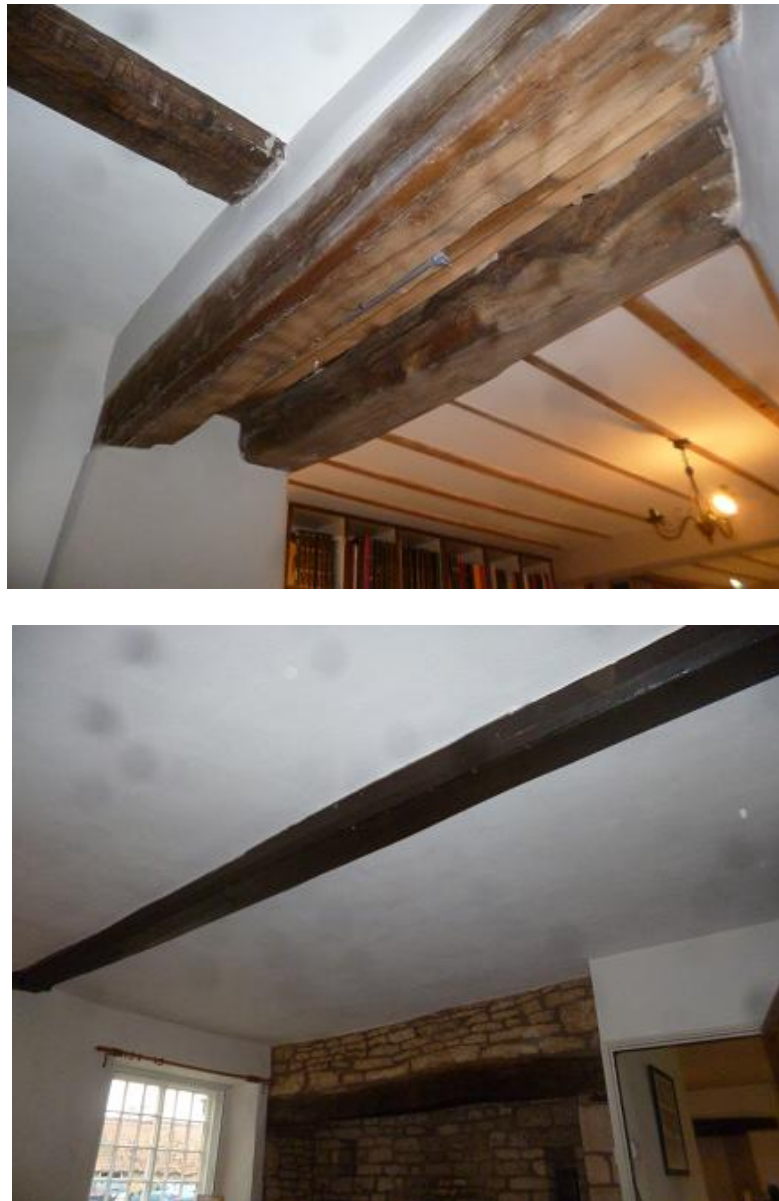
**Figure 6:** View of timbers at Fir Tree Farm

As well as a sixteenth century timber, Fir Tree Farm contains some later timbers as well, these being dated as constituents of site sequence CTMASSQ02. Three of these timbers, the west ceiling beam to the living room, and the ceiling beam and the fireplace bresummer of the dining room, (represented respectively by samples CTM-B06, B07, and B08), are likely to have been felled together at the same time in 1709. Such an interpretation is based on the fact that two of these samples, CTM-B06 and B08, both retain complete sapwood, this meaning that they both have the last growth ring produced by the source trees before they were felled (this being indicated by upper case 'C' in Table 1 and the bar diagrams). These last sapwood rings, and thus the felling of the trees, are both dated to 1709.

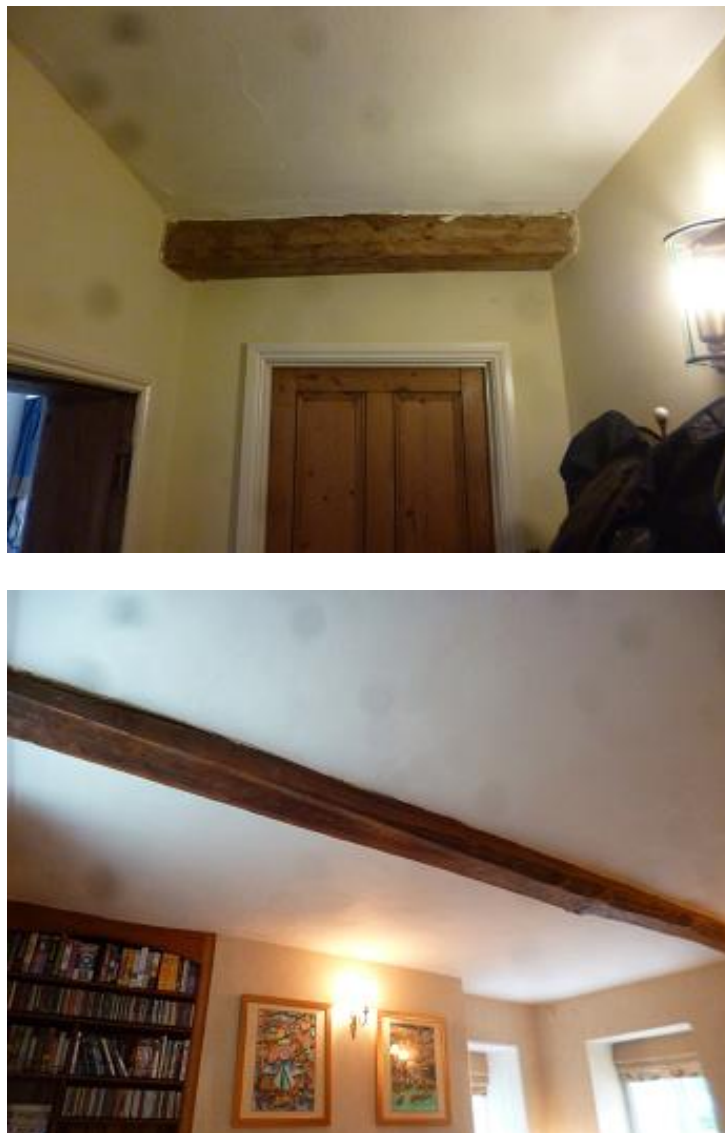
**Figure 7:** View of timbers at Holme Farm

Potentially the oldest timber is represented by sample CTM-C10, from a beam in the hallway of Holme Farm. This sample has a last measured ring date of 1480. Unfortunately, this sample does not retain the boundary between the heartwood and the sapwood (h/s in Table 1 and the bar diagrams). This means that not only has the timber lost all its sapwood, but an unknown number of heartwood rings as well (this probably having been removed by the original carpenters). This means that it is not possible to determine when it was felled; in theory the tree could have gone on growing for many decades after 1480. However, given the size of the timber, and that it represents a half a tree, it is unlikely to have been very much bigger, and therefore unlikely to have gone on growing for a great many more years. It might not be unreasonable, therefore, to suggest that the source tree was felled at some point during the first half of the sixteenth century.

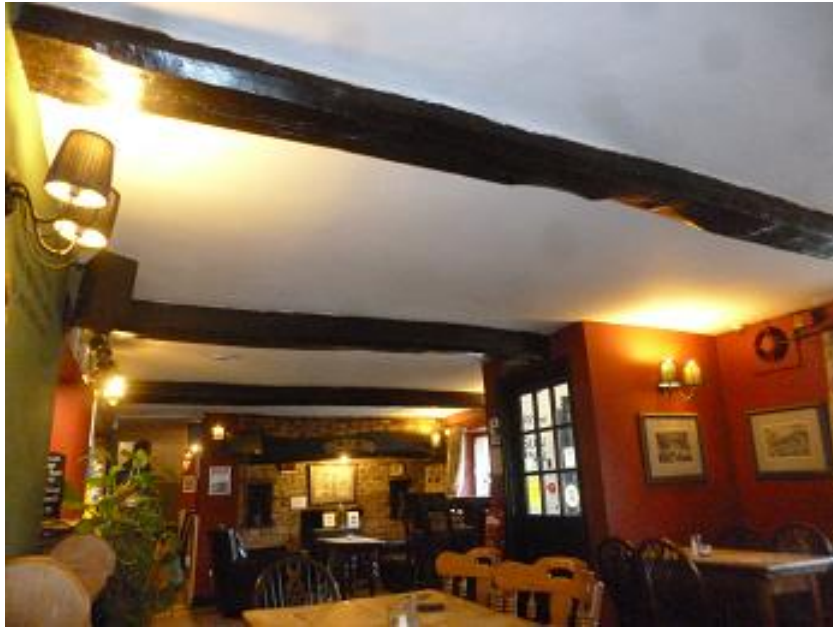
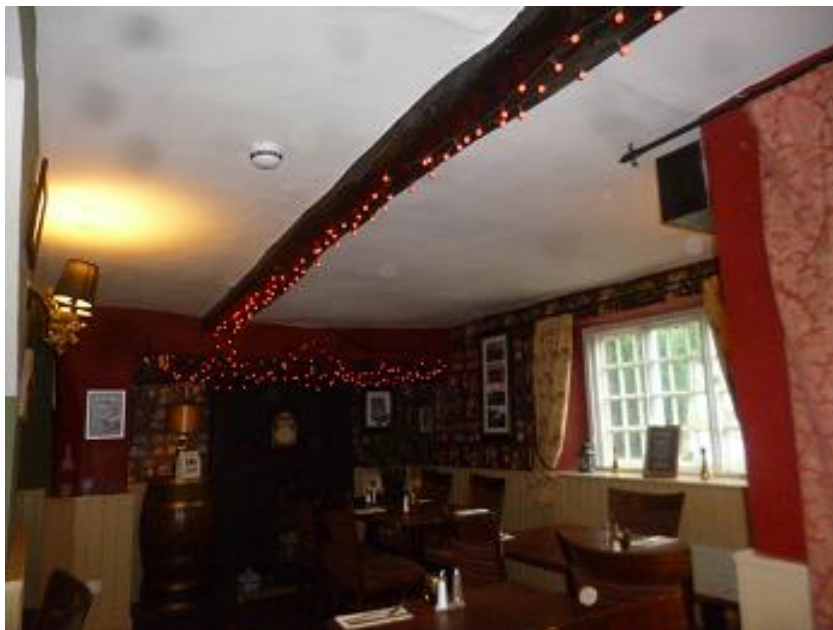
**Figure 8:** View of timbers at the Sun Inn

The next earliest timber is represented by sample CTM-D12, from the east-most ceiling beam in the public bar of the Sun Inn (this sample dated as part of site sequence CTMSSQ01). This sample has a last measured sapwood ring date of 1547, there being 17 sapwood rings on the sample, though the sapwood is not complete to the bark. Given that oak trees usually have up to a maximum of 40 sap wood rings, this indicates that the timber must have been felled at some point between 1548 at the earliest (as it was still growing in 1547) and 1570 at the latest (allowing that it might at most have had another 23 sapwood rings ( $17+23=40$ )).

In addition to its sixteenth century timber, the Sun Inn also contains two later timbers. These are represented by sample CTM-D16 and D17, respectively from the ceiling beam and fireplace bresummer in the restaurant (both samples dated as part of site sequence CTMSSQ03). The position of the boundary between the heartwood and the sapwood on both these samples is virtually identical, suggesting that they were felled at the same time as each other, the average date of this boundary being 1753. Allowing for the usual minimum/maximum number of sapwood rings (15/40), this would give the timbers an estimated felling date of some time between 1768 at the earliest and 1793 at the latest.

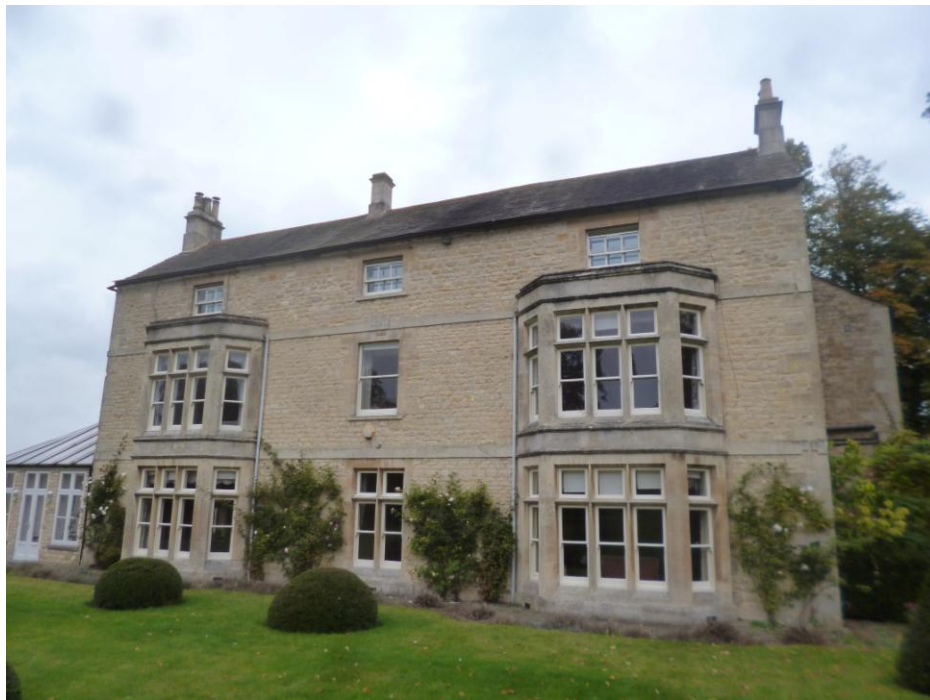
The roof of The Grange comprises six king-post type trusses, a truss form common from the early nineteenth century onwards. Each truss is formed of a tiebeam, principal rafters, and king post with shouldered base and expanded head, there being struts which rise from the shoulders of the king-posts to the principal rafters. The trusses support single, backed, purlins to each pitch of the roof, these in turn supporting common rafters (Fig 3a). All such timbers have been finely sawn and heavily worked to produce very even, square cut, timbers, and are held by wooden pegs in morticed and tennoned joints. It may be of interest to note that many of these joints appear to have been carefully marked out in pencil, there also being other scribing to the timbers, possibly numbers or letters (perhaps 'checking' marks) in red pencil or crayon (Fig 3b). This is a feature that has been seen on several other roofs of this type.

From these timbers a total of 12 cores samples was obtained, each sample being given the code CTM-F (for Cottesmore, site 'F'), and numbered 1–12. The sampled timbers are identified on drawings of the trusses, these being given here as [Figure 4a–d](#). Details of the samples are given in Table 1, including the timber sampled and its location, the total number of rings each sample has, and how many of these, if any, are sapwood rings. The individual date span of each dated sample is also given.

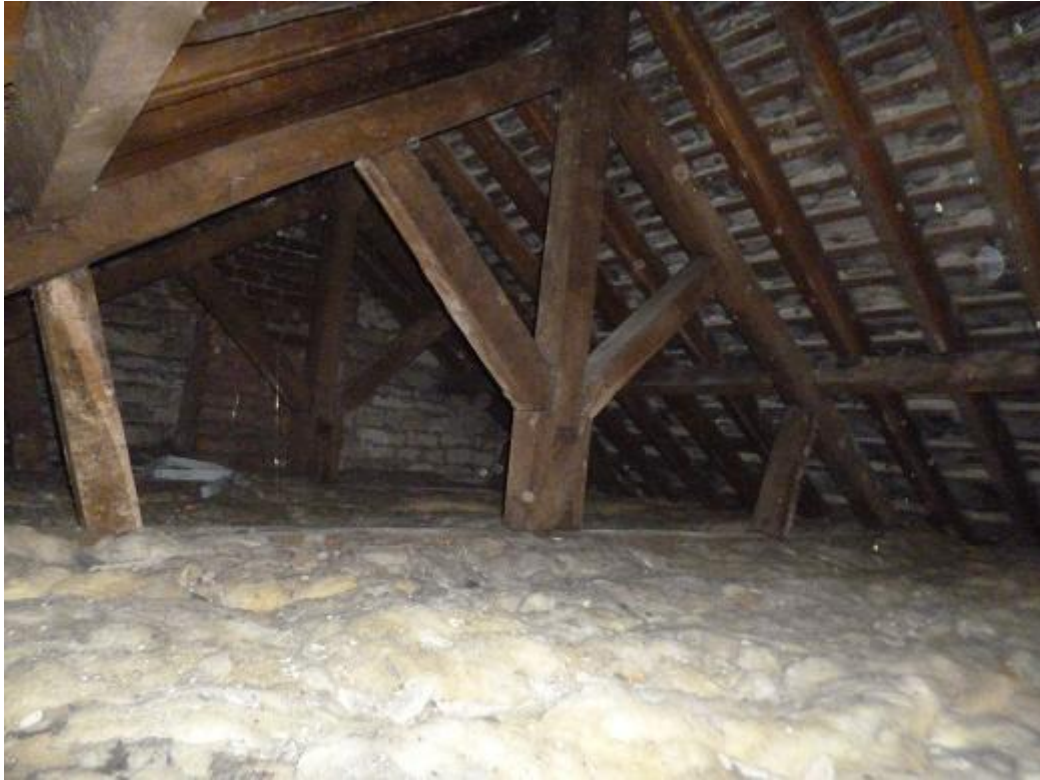
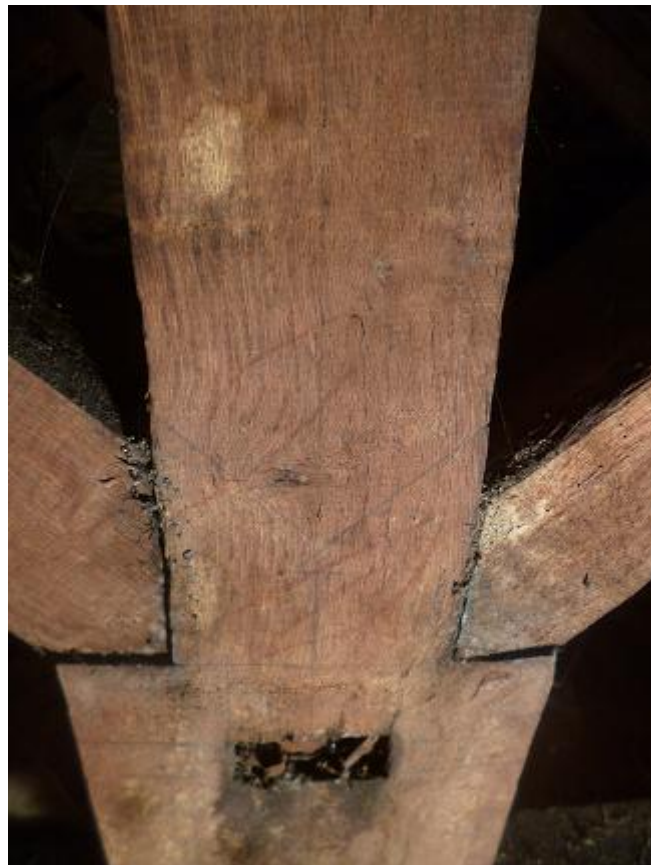
**Figure 10:** View of the roof trusses at the Grange (top) and detail of the marking-out lines and other markings in red on a king-post (bottom)

In addition to the main timbers of the trusses there are other shorter, outer, struts to each truss, these rising from the tiebeam to the principal rafter where the principal supports the purlin. These timbers appear to be much less well worked than the main timbers, being less well sawn or trimmed, and appearing to be much poorer quality wood. It is possible that these shorter struts are inserted as 'afterthoughts', the beams not being jointed to the

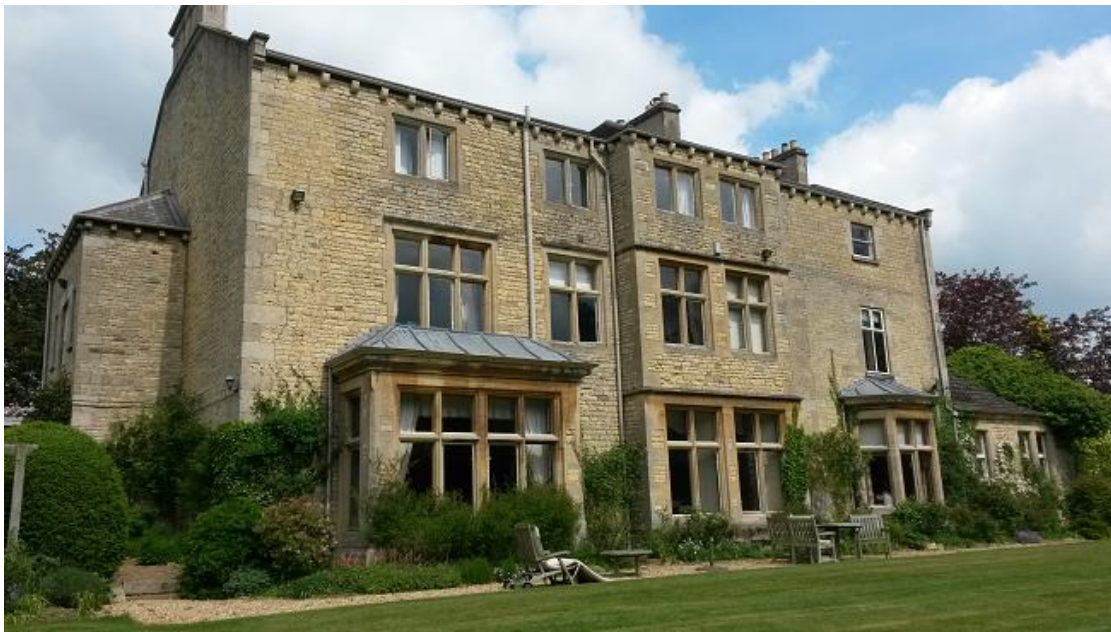
Each of the core samples obtained from the six different beams at Clatterpot House was prepared by sanding and polishing to clearly reveal its annual growth rings, the widths of these then being measured. The data of these measurements was then compared with each other as described in the notes on tree-ring dating above. This comparative process showed that three samples, CTM-G04, G05, and G06, all from the first floor ceiling beams, could be cross-matched with each other at positions as shown in the bar diagram Figure 4. The three cross-matching samples were combined at these positions to form CTMGSQ01, a site chronology with an overall length of 73 rings.

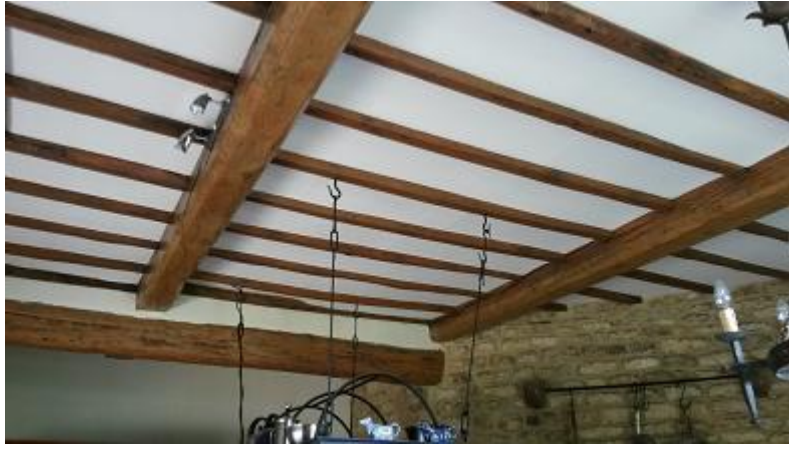
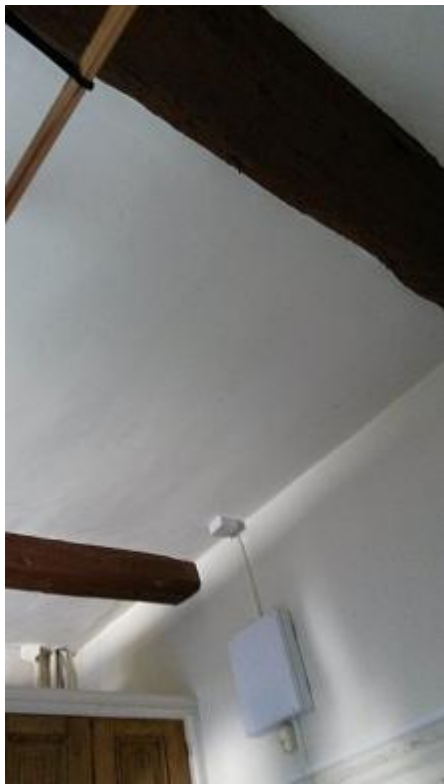
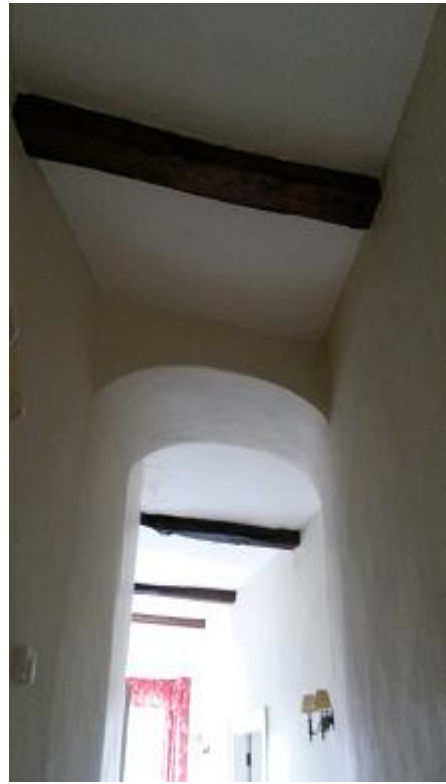
**Figure 11:** View of a selection of timbers at Clatterpot House

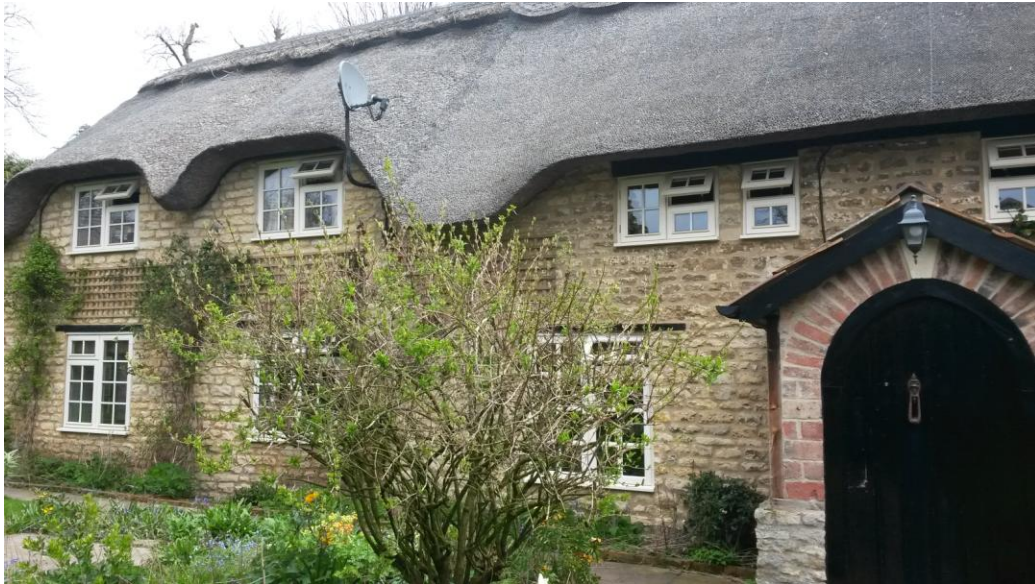
From the timbers available here, three were selected for sampling, the sampled timbers being identified on the annotated photograph, Figure 3, each core being identified by the code CTM-H (for Cottesmore site “H”) and numbered 1–3. Details of the samples are given in Table 1, including the timber sampled and its location, the total number of rings each sample has, and how many of these, if any, are sapwood rings.

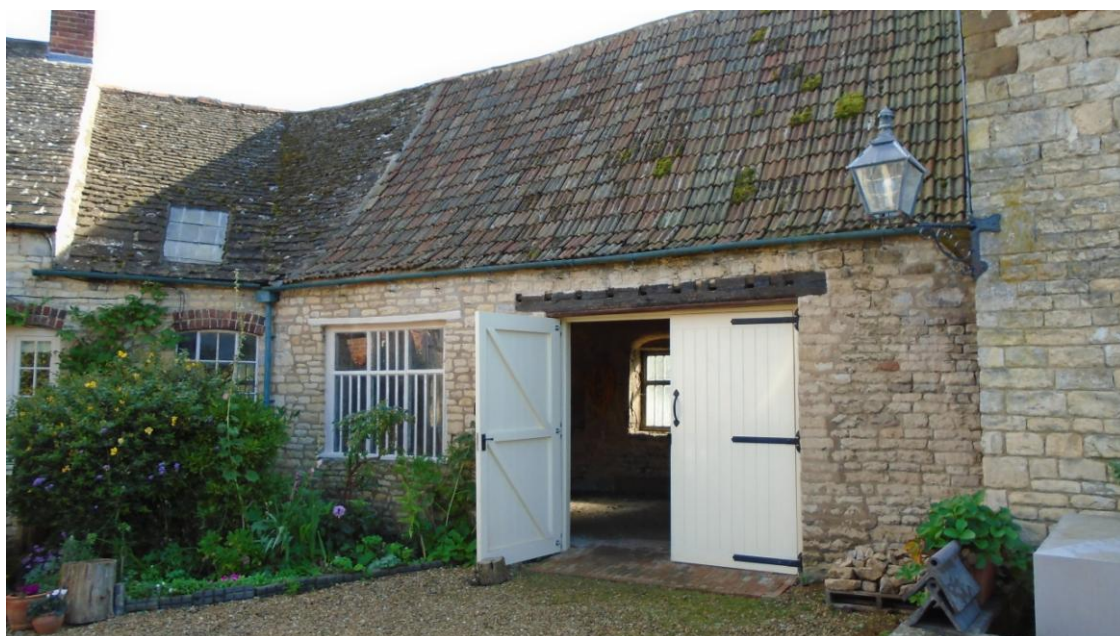
From the timbers available here, three were selected for sampling, the sampled timbers being identified on annotated photographs as Figure 3a/b, each core being identified by the code CTM-I (for Cottesmore site “I”) and numbered 1–3. Details of the samples are given in Table 1, including the timber sampled and its location, the total number of rings each sample has, and how many of these, if any, are sapwood rings

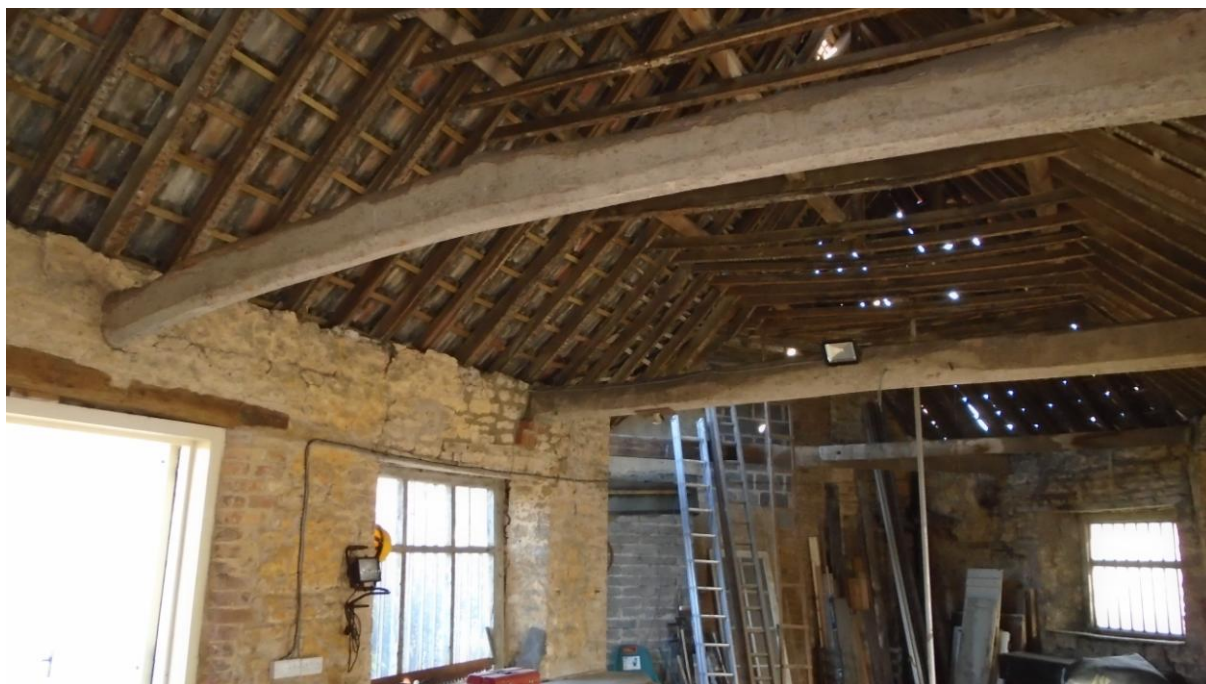
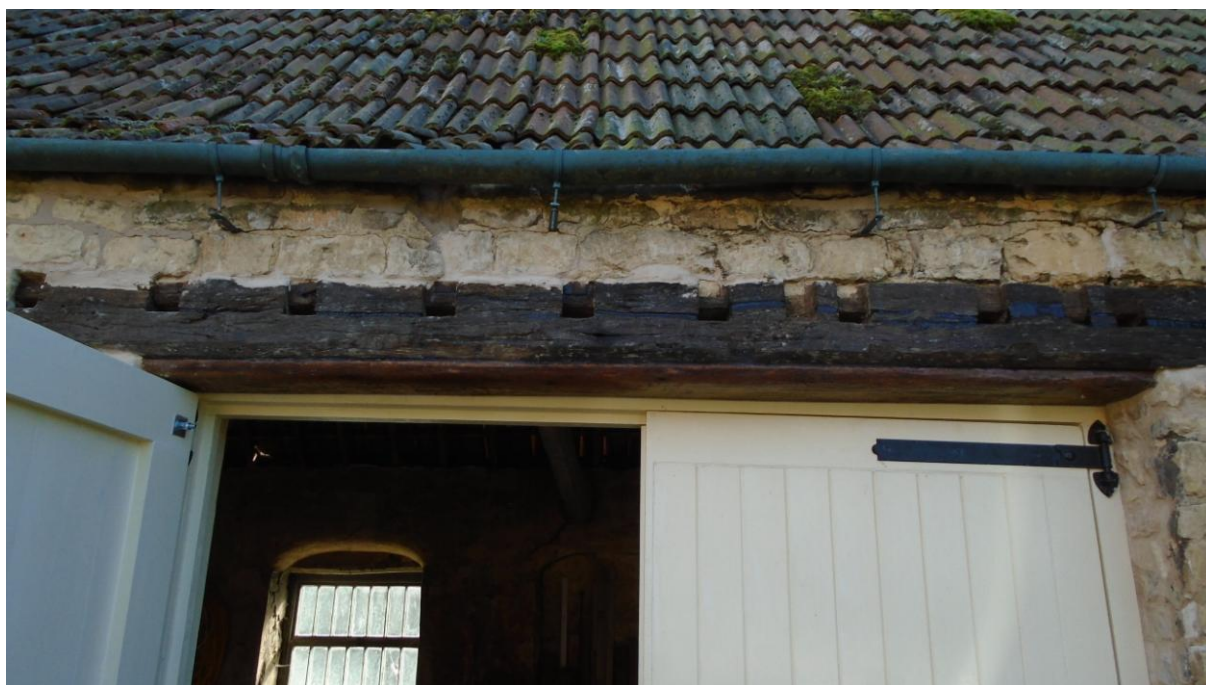
**Figure 12:** Photographs of the timbers at the Granary
